# Drive & Control profile

## White Paper

# Performance testing of composite bearing materials for large hydraulic cylinders

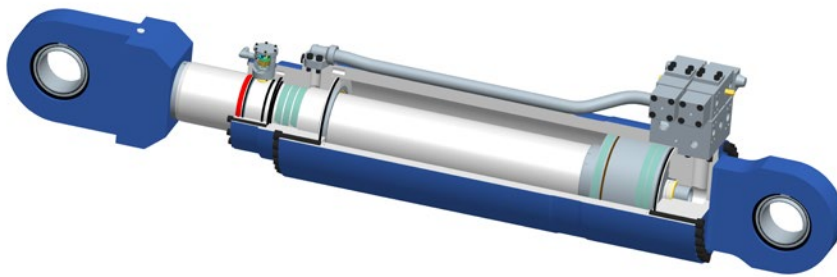
Figure 1: Location of radial bearings and seals in a hydraulic cylinder

Both the piston and cylinder head have radial bearings and seals. Figure 1 shows where the seals and bearings are located. The piston divides the inside of the cylinder into two chambers: the cap end chamber and the rod end chamber.

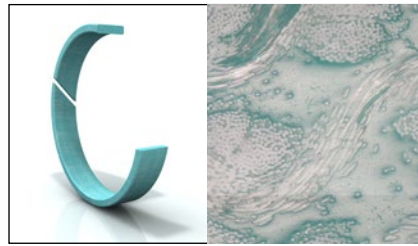
Figure 2: A composite bearing composed of polyester fabric impregnated with a polyester resin—bearing strip and cross section micrograph shown

Composite bearing materials are technical fabrics impregnated with thermosetting resins, i.e., a polymer fabric reinforcement with a thermoset matrix. The most commonly used fabric material is polyester; the most commonly used resins for the matrix are polyesters and phenols. For friction reduction, dedicated additives are used, mostly PTFE powder.
