Drive & Control profile

White Paper

Performance testing of composite bearing materials for large hydraulic cylinders

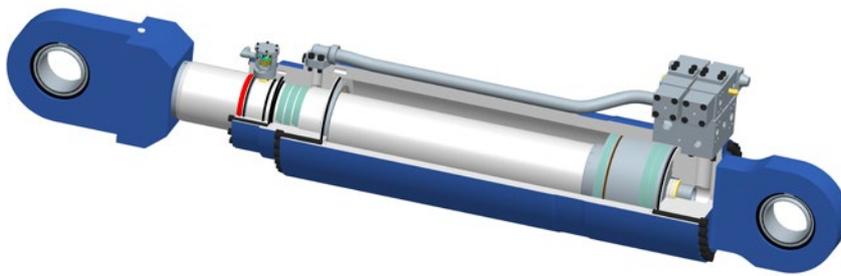
Figure 1: Location of radial bearings and seals in a hydraulic cylinder

Both the piston and cylinder head have radial bearings and seals. Figure 1 shows where the seals and bearings are located. The piston divides the inside of the cylinder into two chambers: the cap end chamber and the rod end chamber.

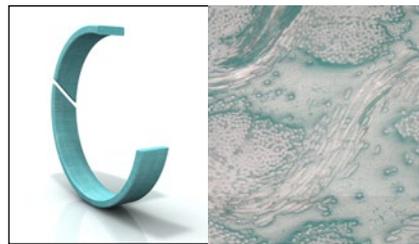
Figure 2: A composite bearing composed of polyester fabric impregnated with a polyester resin—bearing strip and cross section micrograph shown

Composite bearing materials are technical fabrics impregnated with thermosetting resins, i.e., a polymer fabric reinforcement with a thermoset matrix. The most commonly used fabric material is polyester; the most commonly used resins for the matrix are polyesters and phenols. For friction reduction, dedicated additives are used, mostly PTFE powder.

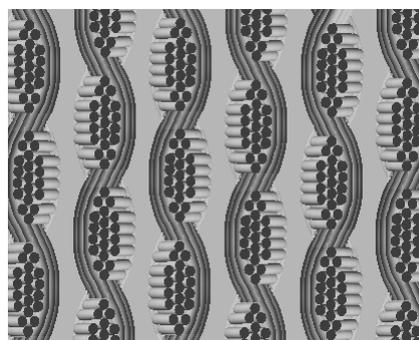
Figure 3: Illustration of bearing strip—polyester fabric structure

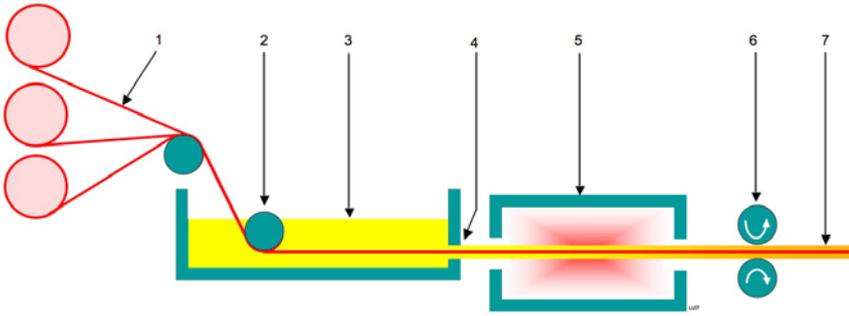
Figure 4: The key steps in the pultrusion process include: 1) Continuous roll feed of reinforced fibers/woven fiber mat; 2) Tension control roll; 3) Resin impregnator bath; 4) Resin-soaked fiber; 5) Bearing die and heat source; and 6) Fiber pull mechanism

In pultrusion, multiple layers of fabric are pulled through a resin bath, where the liquid resin and some additives are present as a mix. When the fabric has gone through the bath, the resin is heat cured in a mold and can be tempered afterward (See Figure 4).

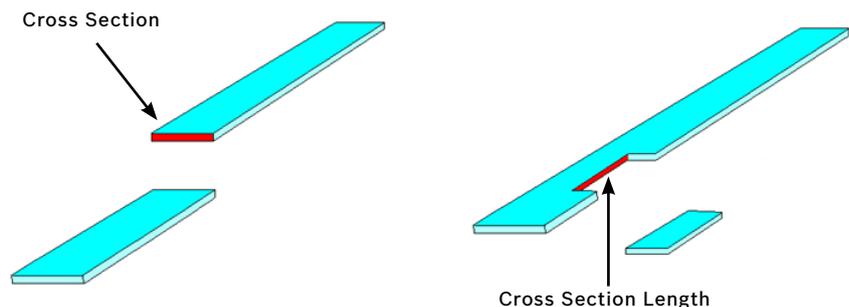
Figure 5: Location of the cross section for microscopic imaging

Step 1—Microscopic imaging: Cross sections were made both in the length and width direction of the radial bearing (see figure 5). The micrographs capture visual data related to the stresses that composite

The microscopic investigation revealed that the radial cross section gives information on the quality of the fabrication process. The transversal cross section gives more information about the composite layer structure and incidence of and distribution of air inclusions.

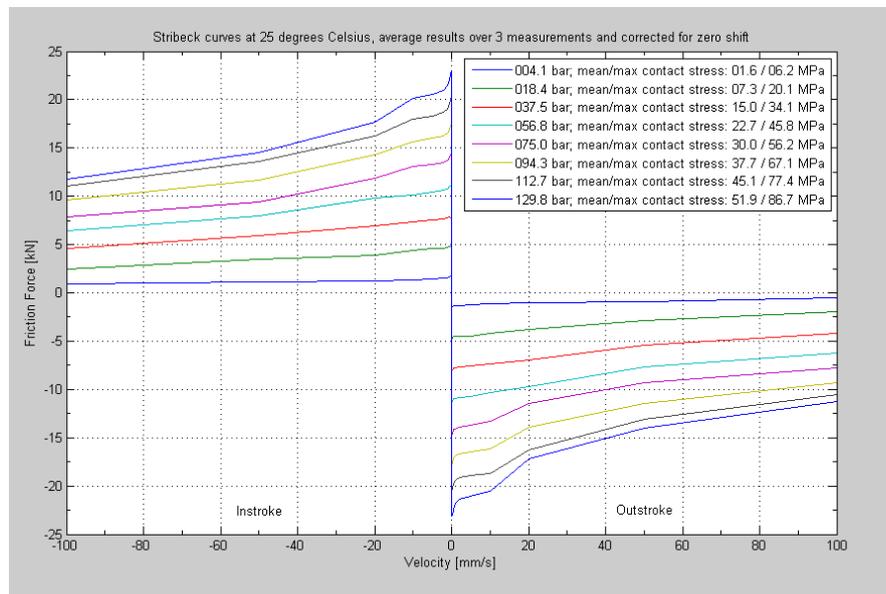
Figure 6: A Stribeck curve of BR non-standard bearing material at 0° angle, general results at 25°C

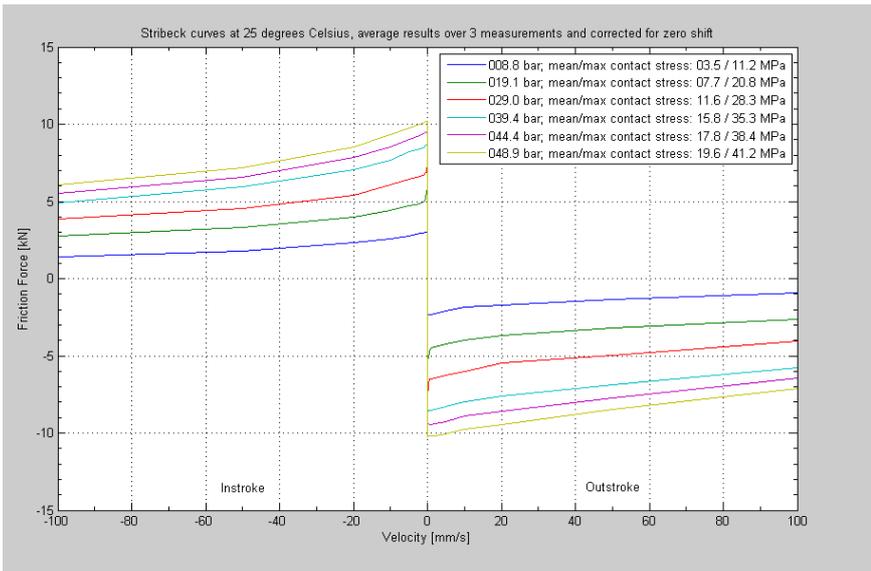
Figure 7: A Stribeck curve of BR non-standard bearing material at 1° angle, general results at 25°C

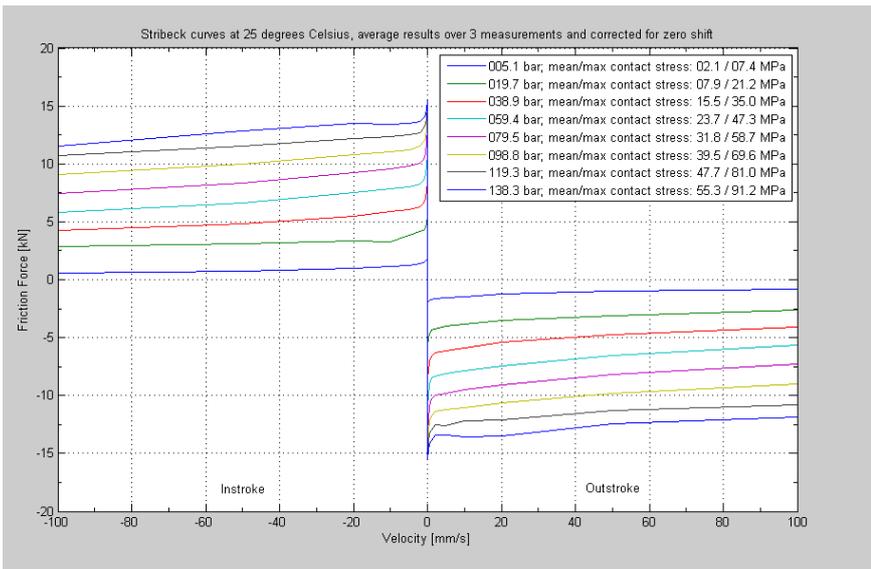
Figure 8: A Stribeck curve of BR standard bearing material at 0° angle, general results at 25°C

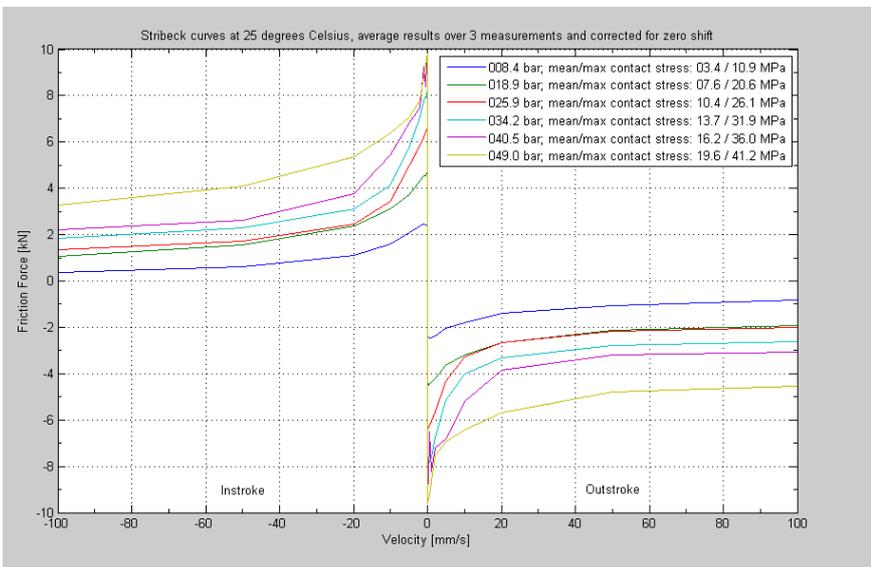
Figure 9: A Stribeck curve of BR standard bearing material at 1° angle, general results at 25°C

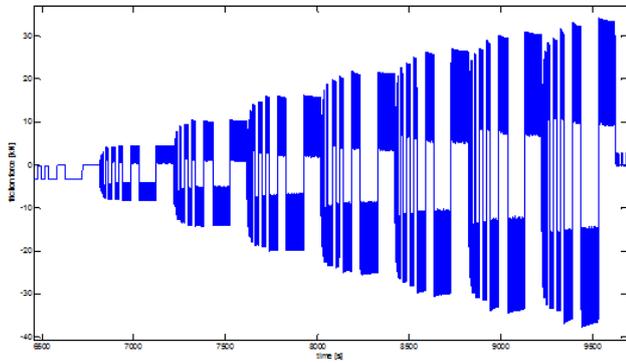
Figure 10: A stick-slip curve of BR non-standard bearing material at 0° angle

Stick-slip curve measurements can show the presence or absence of stick-slip effects, and to what degree. The fluctuation in the friction line graph (circled in red) shows the presence of stick-slip phenomena.

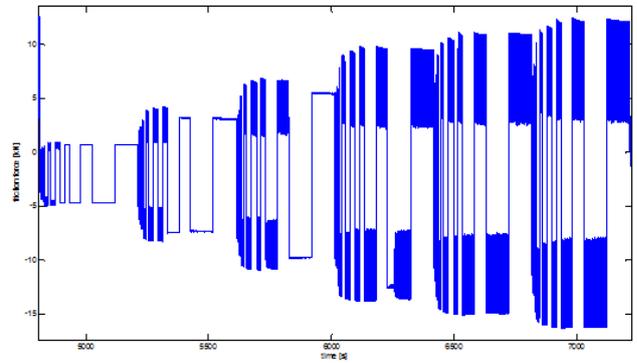
Figure 11: A stick-slip curve of BR non-standard bearing material at 1° angle

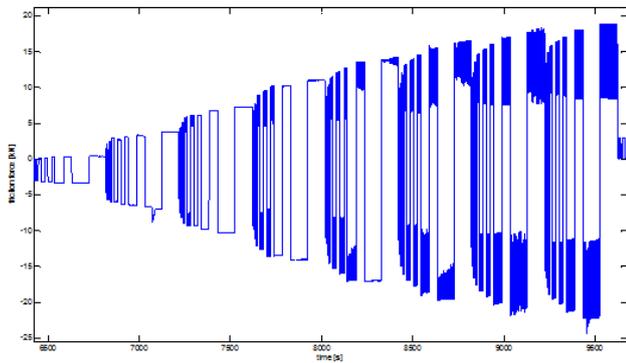
Figure 12: A stick-slip curve of BR standard bearing material at 0° angle

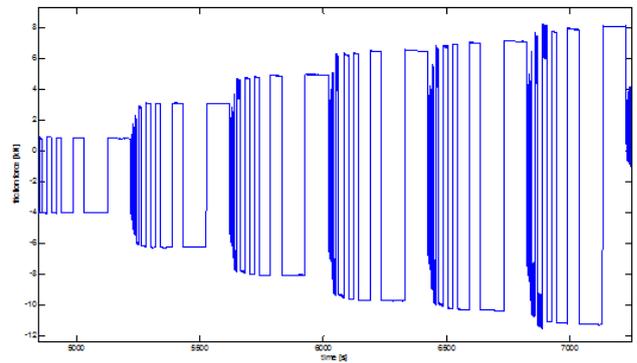
Figure 13: A stick-slip curve of BR standard bearing material at 1° angle

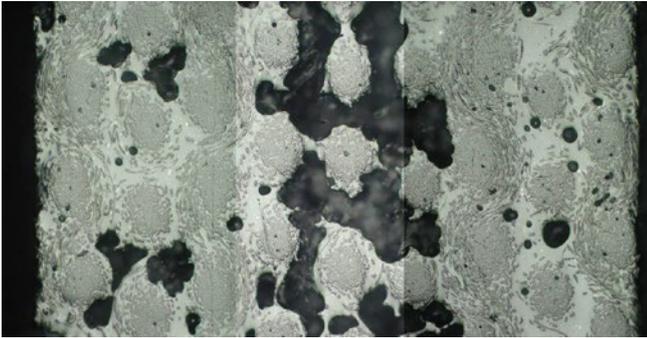
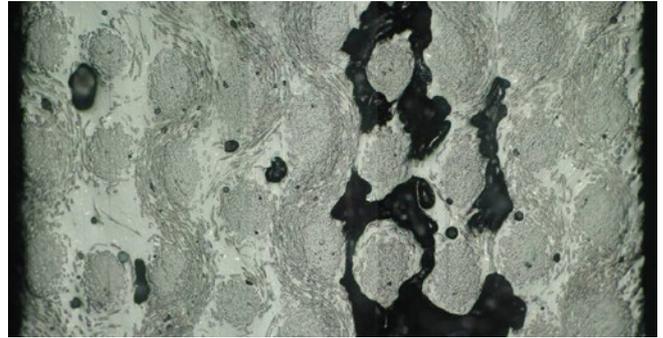
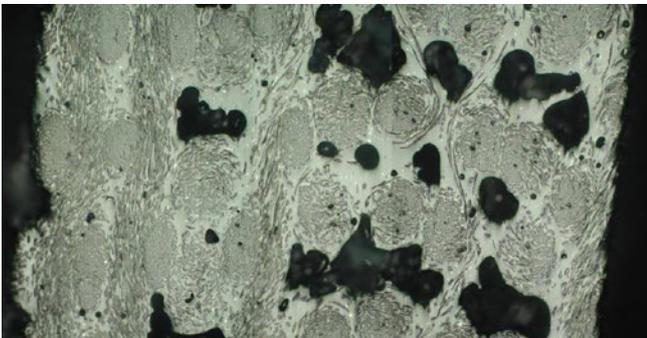
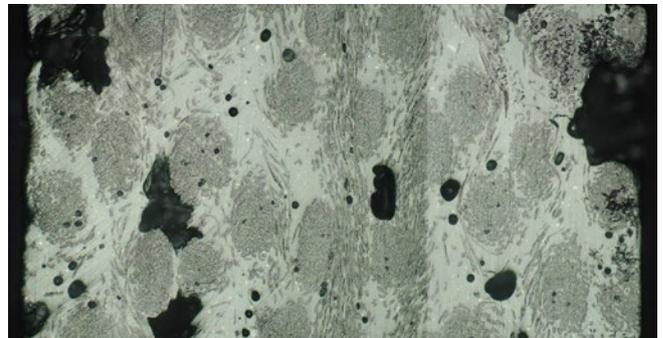
Sample bearing imaging prior to test

Sample bearing imaging post load test

- After the test, the composite material had a deformation of maximum 0.16 mm and a few cracks.
- The structure of the tested material sample showed no cracks at the new strip; however, quite a few big air inclusions were identified with initial microscopic imaging, some of which underwent expansion after load bearing.

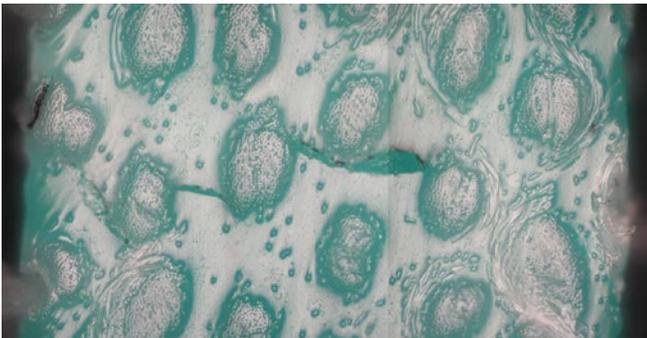
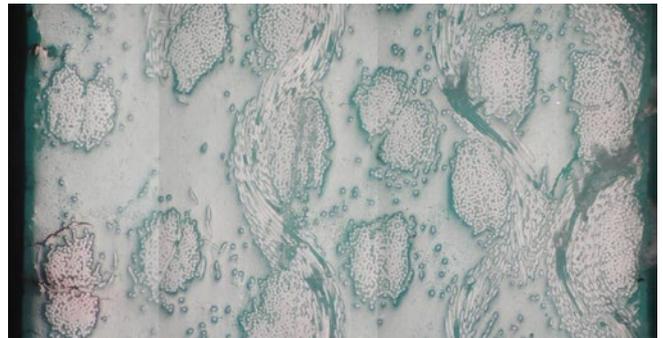
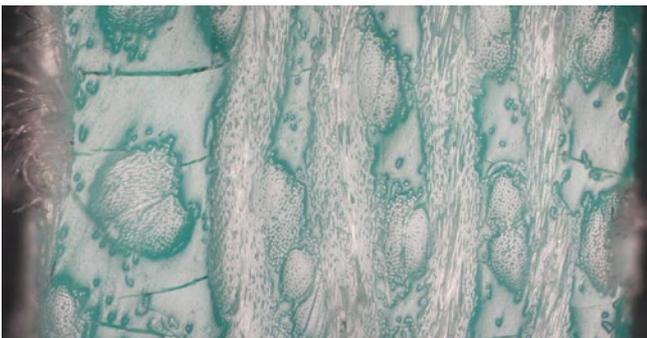
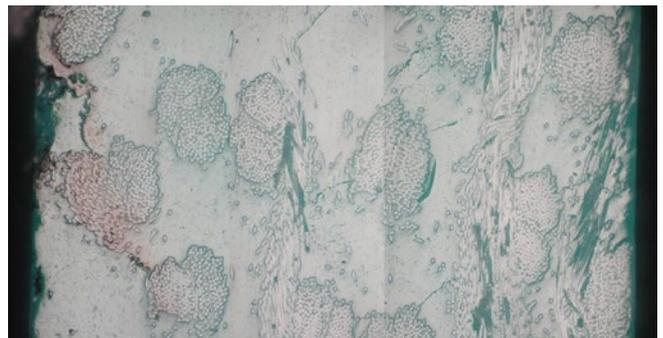
Rexroth standard bearing imaging prior to test

Rexroth standard bearing imaging after load test

- After the test, the composite material had a deformation of maximum 0.17 mm and some cracks.
- The structure of the tested material sample had a minimum of air inclusions, but cracks were detected through post-load test microscopic imaging.
- A comparison of the microscopic imaging of the sample bearing and Rexroth standard bearing materials shows significant air inclusions in the sample bearing material, which expanded after friction testing. Although the Rexroth standard bearing material showed no evidence of air inclusions, stress cracking and some deformation was detected.

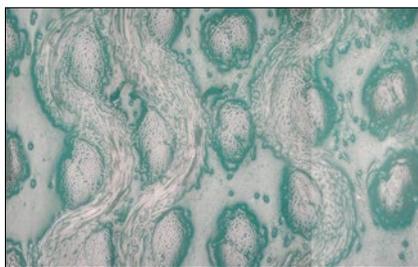
Microscopic imaging of Rexroth bearing material after pultrusion process optimization

As a result, further refinements of Rexroth's standard composite bearing material were undertaken. Rexroth, in close cooperation with the supplier, optimized the pultrusion process and came to a higher standard. The goal of this optimization was reducing the cracks and air inclusions in the matrix and therefore the weak spots. This was done by adjustment of the process speed of the pultrusion process. As a result, the composite

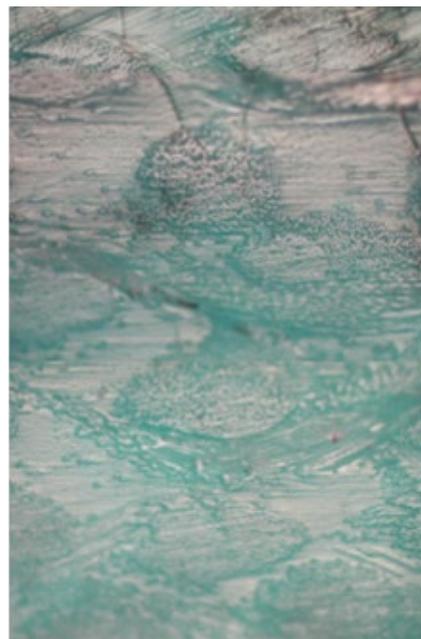
Micrograph results after testing:

After testing there are only a few small cracks present in the top of the sample where the bearing strip is exposed to the highest loads (dynamic friction, shearing and stresses). There are no air inclusions or cracks present in the material itself, which is a direct result of the optimization of the pultrusion process.

- Test cylinder shell diameter 200 mm/diameter rod 170 mm/stroke 2,200 mm
- Test performed with 5% side load resulting in approx. 214.5 MPa
